Orthopädische Klinik und Poliklinik, Universitätsmedizin Rostock

**Experimentelle Analyse des
Verschleißverhaltens künstlicher
Hüftendoprothesen unter dem Einfluss von
Drittkörperpartikeln**

Kumulative Dissertation

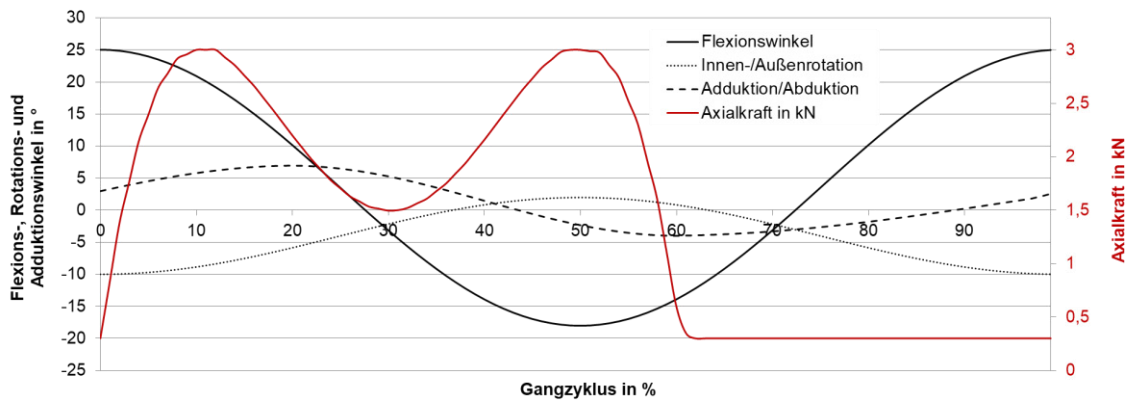
Abbildung 1: Bewegungen und Belastungen im Abriebsimulator nach ISO 14242-1 [39].

Der Abriebtest wurde in einem Standard-Hüftabriebsimulator (C6/2-08, EndoLab GmbH, Rosenheim, Deutschland) durchgeführt. Dabei standen für jede Materialkombination je drei Stationen für die dynamische Testung zur Verfügung. Auf diese wurden die durch die ISO 14242-1:2014 [39] vorgegebenen fünf Mio. Last- und Bewegungszyklen des normalen Ganges bei 1 Hz aufgebracht (siehe Abbildung 1).

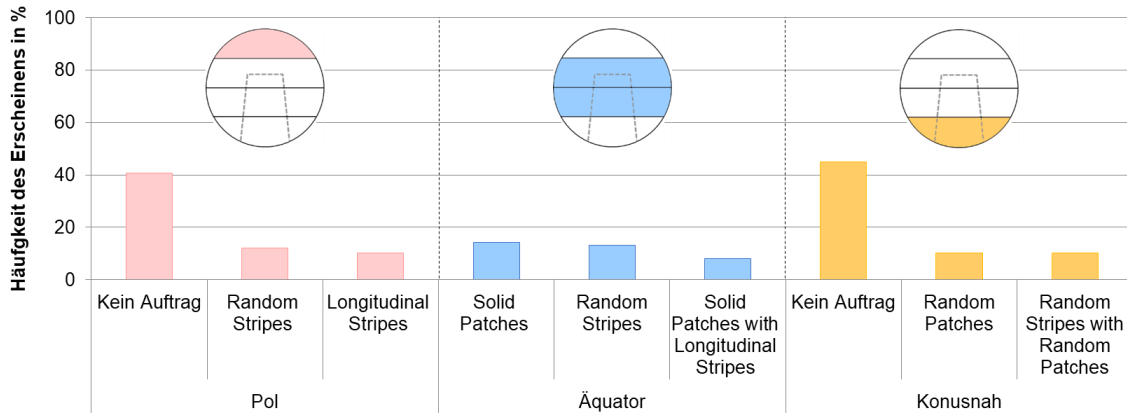
Abbildung 9: Häufigste Auftragsmuster auf den explantierten Köpfen in den Bereichen Pol, Äquator und konusnah.

Es zeigte sich, dass Solid Patches vermehrt im Zusammenhang mit Dislokationen und hauptsächlich im Bereich des Äquators auftraten. Mögliche Zusammenhänge zeigten sich auch beim Auftreten von Random Stripes bei Glutealinsuffizienz und Implantatbruch.

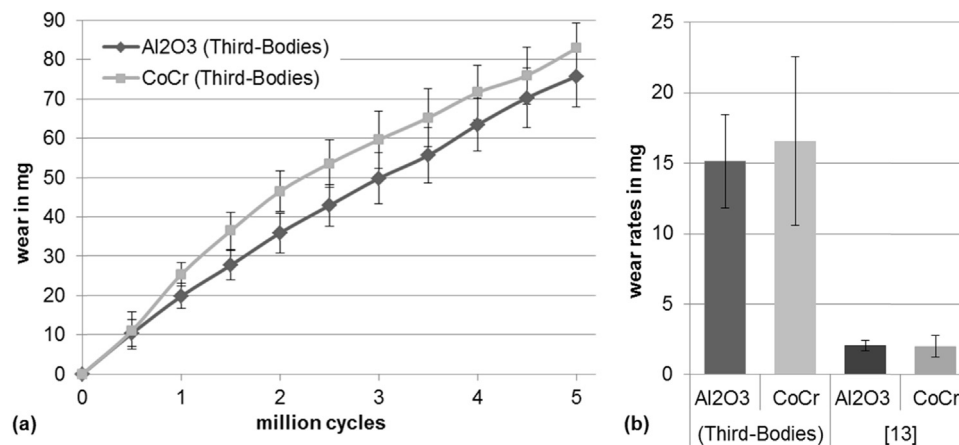
Fig. 4. Mean gravimetric wear of the sequentially cross-linked polyethylene inserts combined with 36 mm diameter femoral heads of alumina ceramic and CoCr modified with nitrogen treatment; (a) under third-body conditions, (b) wear rates per million cycles with and without third-body particles.

The mean amount of gravimetric wear from third-body particles and standard test conditions for the sequentially cross-linked polyethylene combined with metallic and ceramic heads are presented in Fig. 4. Both

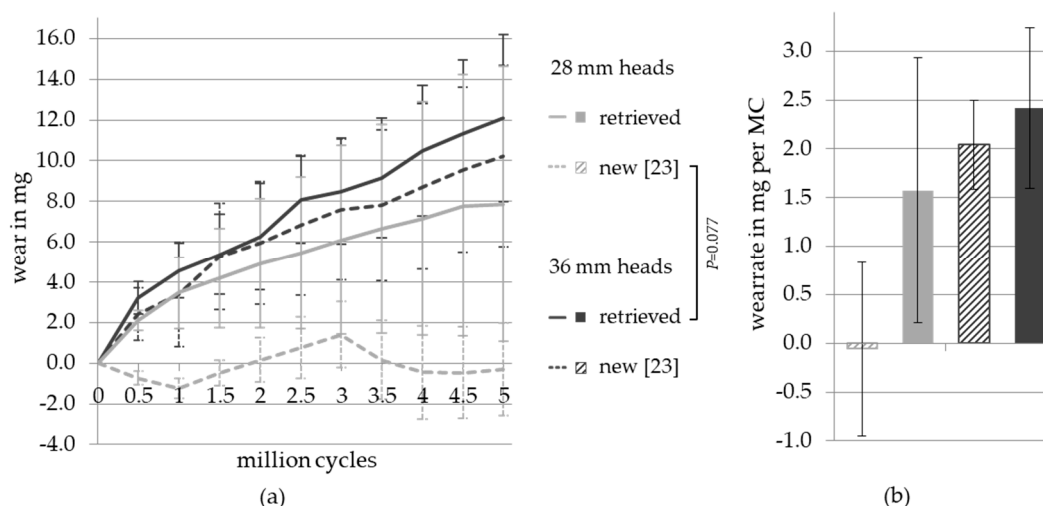
Figure 2. Mean gravimetric wear of the sequentially cross-linked polyethylene (PE) liners combined with new [23] and retrieved 28 and 36 mm alumina femoral heads. (a) Total wear over five million cycles and (b) wear rates per million cycles.

The gravimetric wear of the PE liners combined with new and retrieved ceramic femoral heads with metallic transfer (28 and 36 mm diameters) is shown in Figure 2. The graphs show an almost linear increase in wear over five million cycles (Figure 2a), whereby the wear of the liners articulated against the retrieved femoral heads (36 mm head size) was the highest across all five million cycles (MC), with a total wear of (12.09 ± 4.12) mg ((2.42 ± 0.82) mg per MC). This was followed by liners articulated against the new femoral heads (36 mm head size), with a total wear of (10.21 ± 2.28) mg ((2.04 ± 0.46) mg per MC) and by liners articulated against retrieved 28 mm femoral heads with metallic depositions, with a total wear of (7.86 ± 6.79) mg ((1.57 ± 1.36) mg per MC). The combination of PE liners with new 28 mm femoral heads from the standard test showed nearly no change in gravimetric weight, with a total wear of (-0.29 ± 4.45) mg ((-0.06 ± 0.89) mg per MC). For determination of all wear rates, the zero value was included.

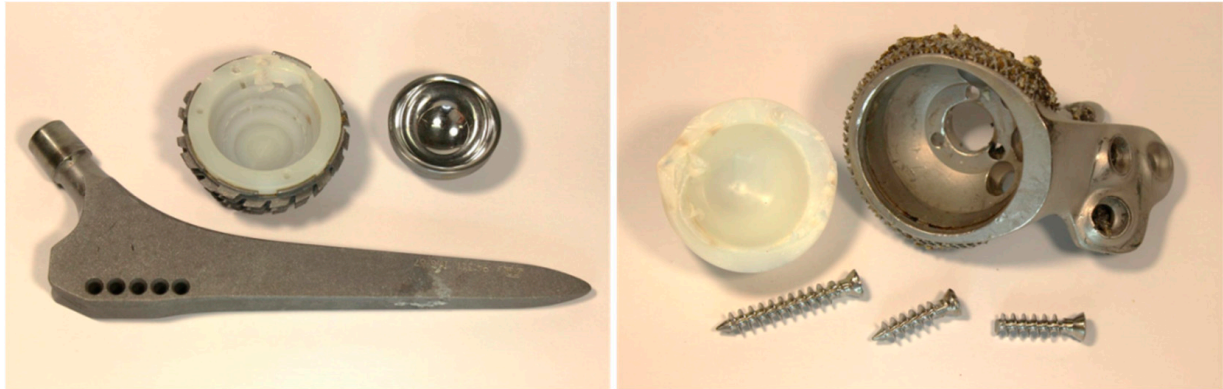
Figure 4. Examples of revised total hip implant systems.

In order to determine the cause of the revision, revised total hip implant systems (if available) were also examined in addition to the retrieved heads (see Figure 4).

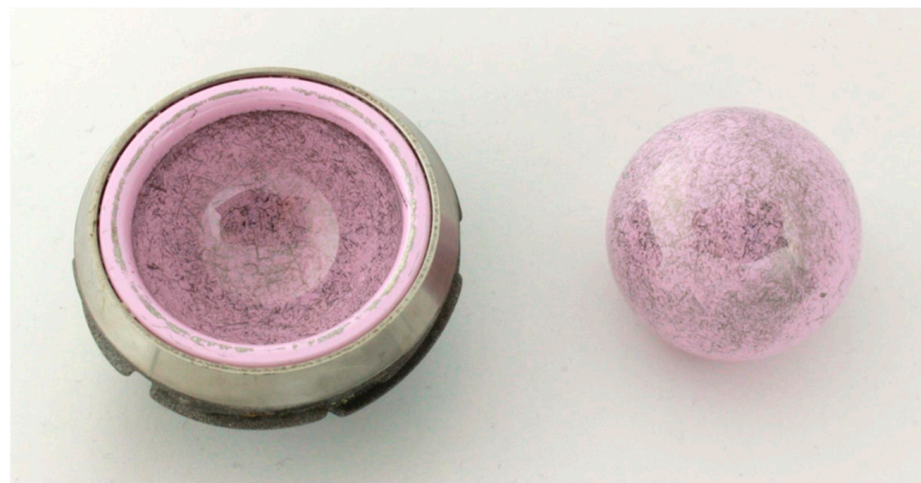
Figure 5. Ceramic-on-ceramic bearing couple with globally distributed metallic deposition on femoral head and insert.
